Manhole Inspection Summary

Manhole # S41AA_025MH

Insp Date: 11/11/08 3:30 PM

Location Address: **1214 e madison st**

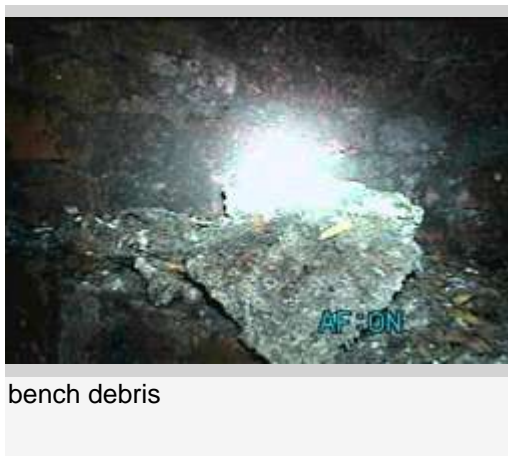
MISC

bench debris

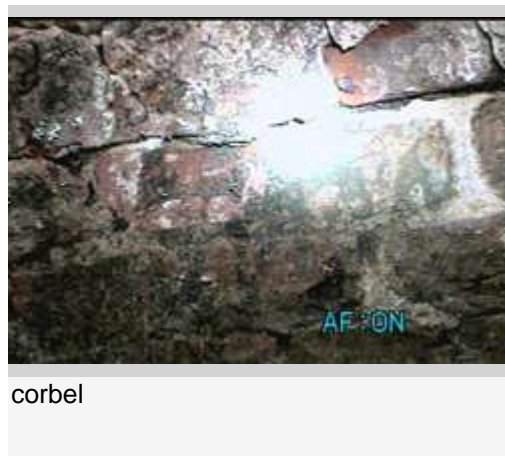
Defect 2

Condition: ☐ Sound ☒ **Cracked** ☐ Root Intrusion ☒ **Loose Brick** ☒ **Deteriorated**

corbel

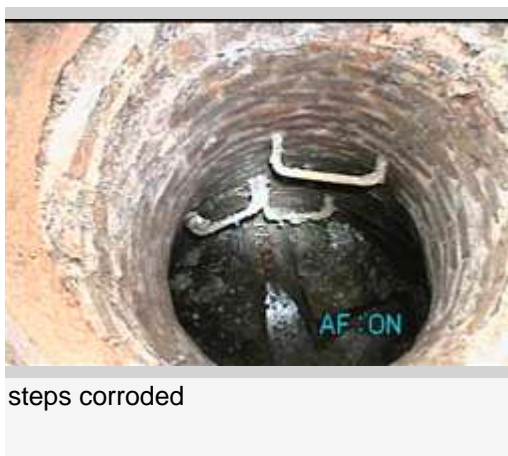
Defect 3

Count: **3** Missing: **0** ☒ **Corroded**

steps corroded

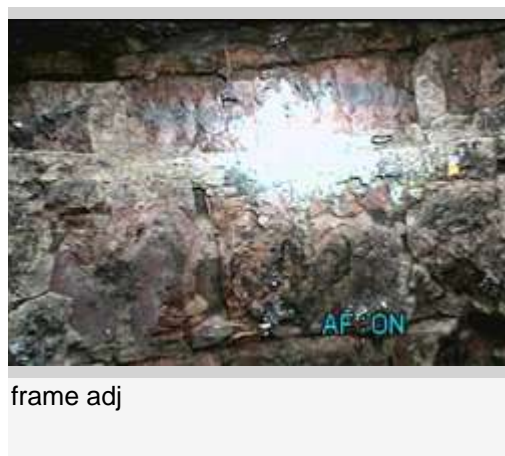
Defect 1

Condition: ☐ Sound ☒ **Cracked** ☐ Root Intrusion ☒ **Loose Brick** ☒ **Deteriorated**

frame adj

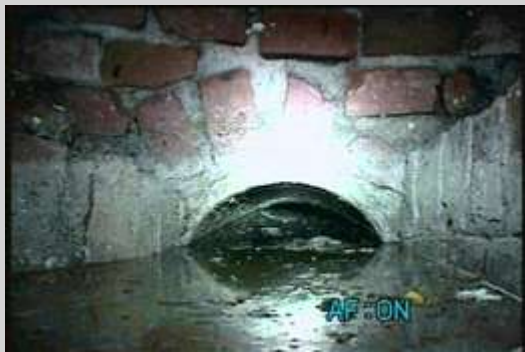
12 O'Clock Outflow

best shot due to still water

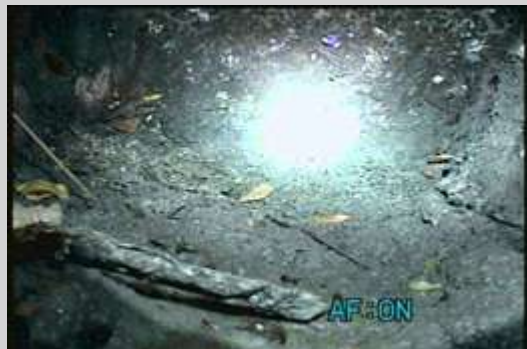
9 O'Clock Inflow

closed off
